# CORNET: IN2EUROBUILD - CONSISTENT EUROPEAN GUIDELINES FOR INTERNAL INSULATION OF BUILDING STOCK AND HERITAGE

## Guideline part 1: **Building Assessment**

247 EBG

**30. November 2022**

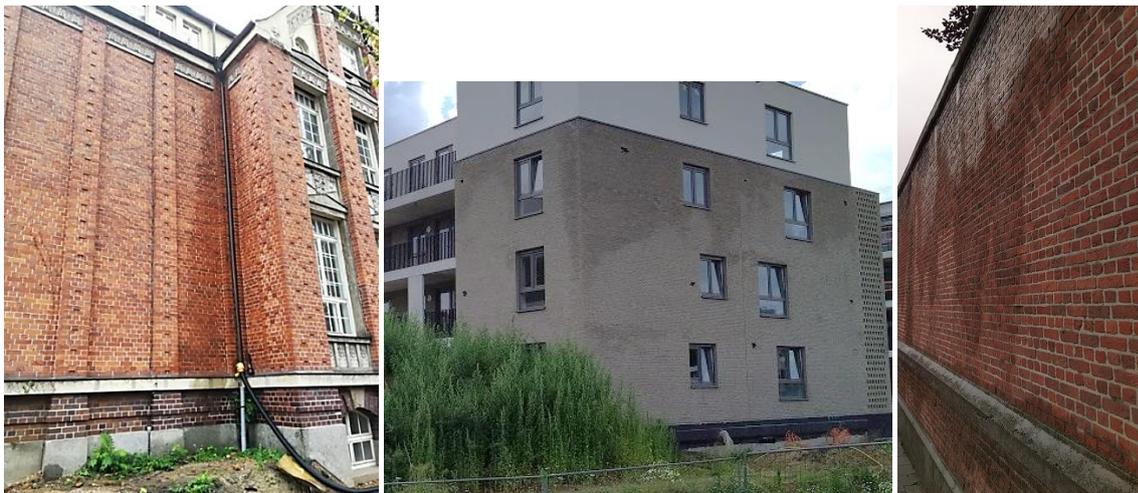
Fig. 5 Inspection after a rain event to visually check the moisture distribution on façade surfaces. Left: visible moisture load due to defective temporary rain water downpipe; middle/right: exposed parts become visible

In some cases, the cause of the detected structural damage can be easily removed, e.g. by replacing a defective roof drainage system or provisionally closing defects in the envelope structure. In the case depicted in Fig. 5, a down pipe had to be fixed to avoid moisture accumulation in the wall.

It might be beneficial to perform a visual assessment during rainy weather, or in a rainy period. This allows directly to check if certain façade areas are very exposed to rain, and which areas are protected (Fig. 5, middle and right).

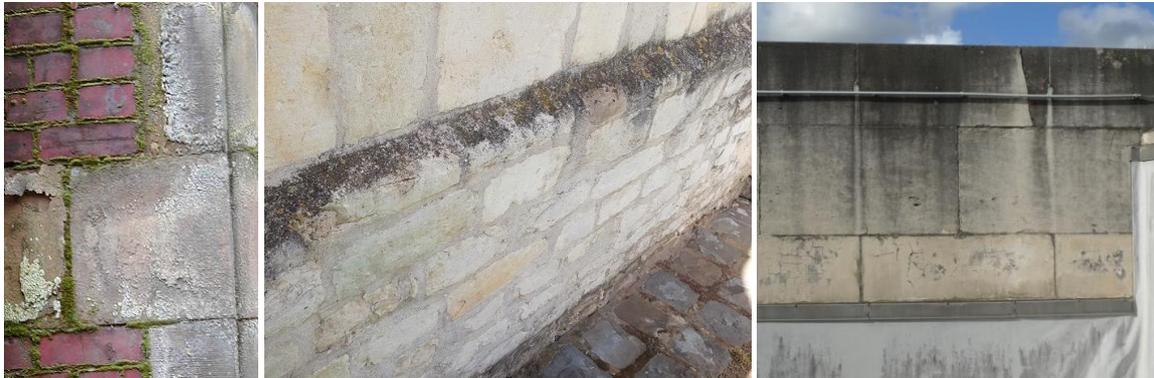
Fig. 6 Biological growth of moss, algae and bacteria showing where facades are exposed to rainwater

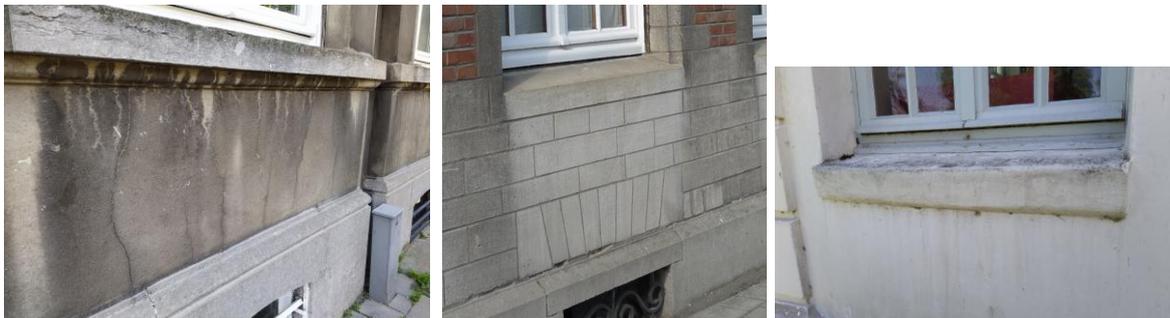
Fig. 7 Differences in pollution under a window sill. Left: apart from some runoffs, the surface under the window sill is well protected from water, as it is sooty; middle: cleaner surface under the sill, indicating it is exposed to rain; right: the runoffs of water under the sill can easily be observed

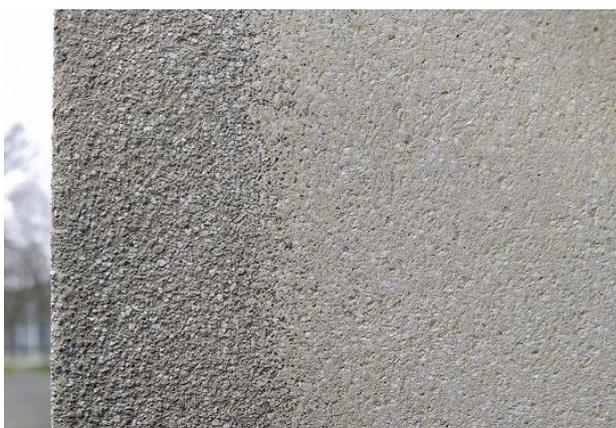
Fig. 8 Different condition of the surface, in this case the washing out of the binder, may indicate differences in driving rain load exposure

Moreover, visual signs of runoffs, such as the pattern of pollution of a façade, may offer a clear view on the exposure. Depending on the kind of dirt (soot, bacteria, algae, etc.) one might observe a different intensity of dirt on facades (Fig. 6 and Fig. 7). Soot usually is more present on parts of facades that are less exposed to rain, whereas bacteria or algae are usually more present on parts of facades that are more exposed to rain or humidity and dry out slower (for instance north faced facades). Sometimes differences in rainwater exposure are shown by a changing intensity of damage to façade materials (Fig. 8 and Fig. 9).

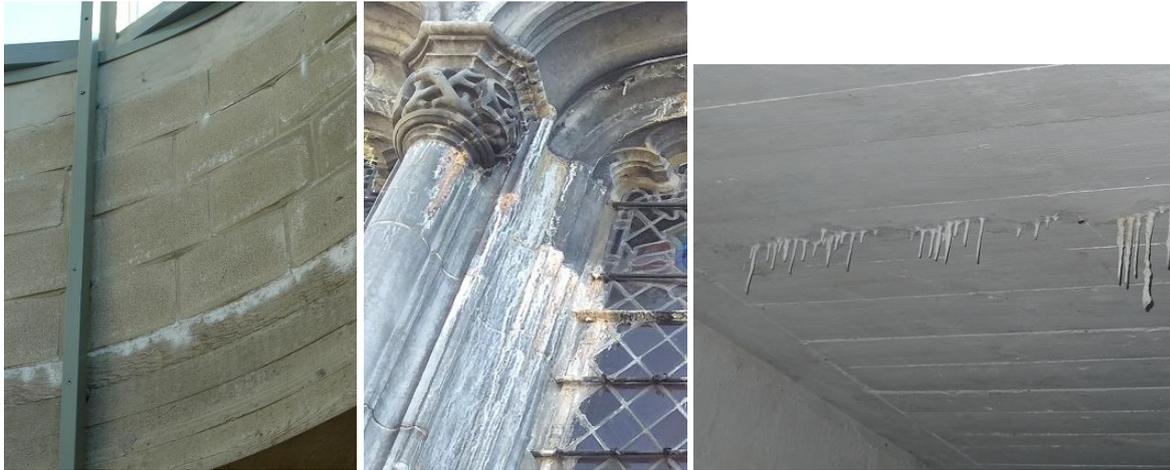
Fig. 9 Often, rainwater infiltration causes  $\text{Ca}(\text{OH})_2$  to be washed out of concrete or mortars and deposited on surfaces where it turns into calcite. Such white run-off, sometimes even visible as stalactites, is a very clear sign of infiltrations. The presence of such run-off indicates a serious problem. It can lead (in concrete structures for instance) up to significant material damage and stability problems (degradation of mortars, increased corrosion of steel reinforcement bars in concrete)

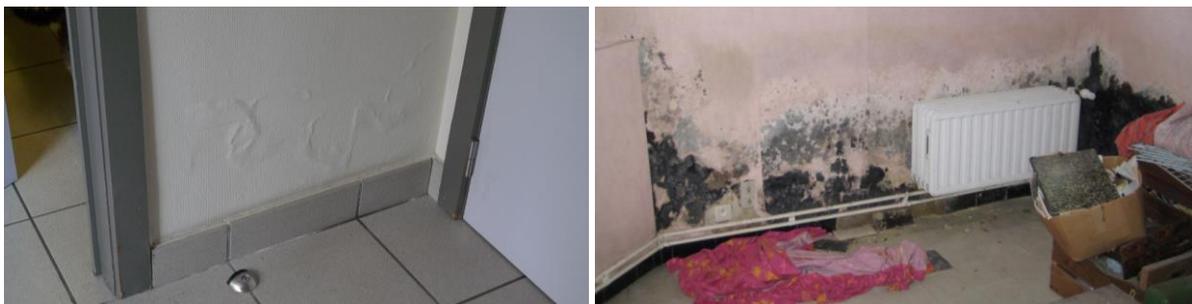
Fig. 10 Rising damp visible on the interior surface of an inner wall (left) and an outer wall (right)

Moisture measurements can be used to determine whether rising damp is actually present. Walls with rising damp are driest on the surface and become wetter inside the wall. Walls are also dampest near the base of the wall and become drier higher up the wall.

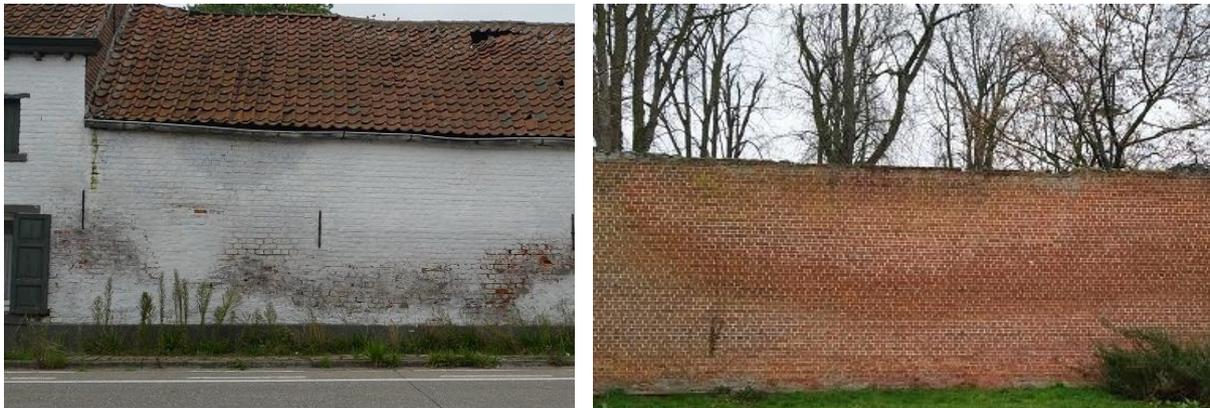
Fig. 11 Purely visually, it is not always easy to distinguish the moisture source. Left: dampening caused by rising damp. Right: dampening caused by hygroscopic salts

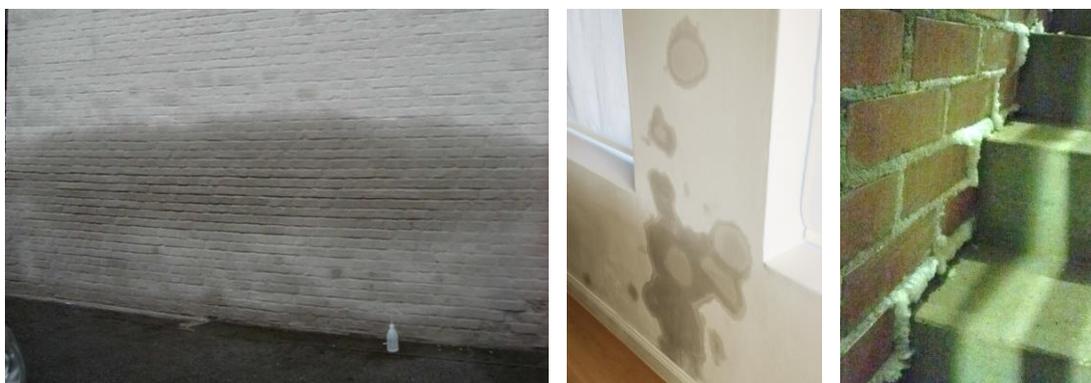
Fig. 12 Hygroscopic moisture and salts on an outer (left) and inner wall (centre); right: on the surface, salt crystallises out

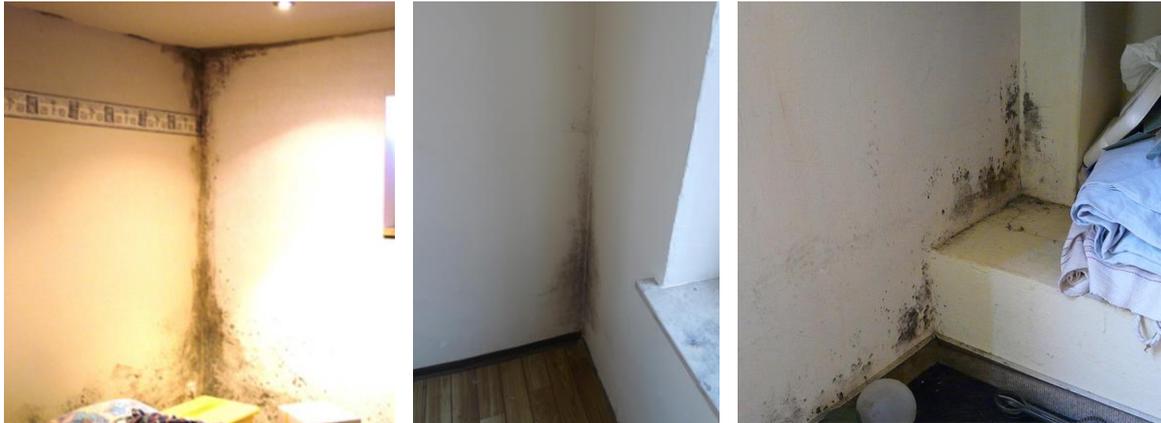
Fig. 13 Mould/condensation in the area of thermal bridges

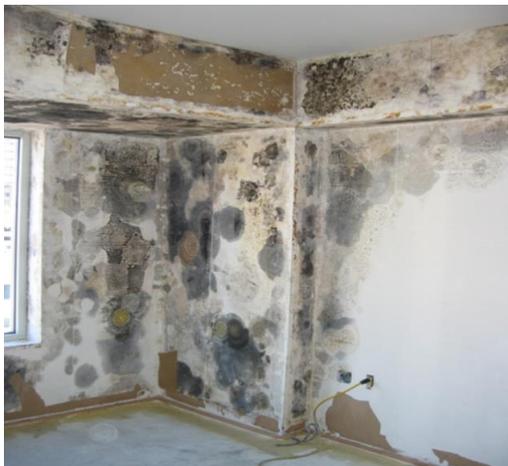
Fig. 14 Significant mould growth behind a removed PVC wallpaper (Wiss J. Elstner Associates, Inc.)

- Flaking of coating: usually because of salt crystallization behind the paint layer, or frost at the interface between the paint and the material underneath.
- Damage to renders or plasters, under the form of cracking, losing cohesion, flaking ... usually due to salts or frost.
- Wallpaper peeling off: usually because of dissolving glue when getting wet. In addition, in the case of very diffusion-tight paints and PVC wallpapers, excellent growth conditions for microbial growth can be present behind this layer (Fig. 14).

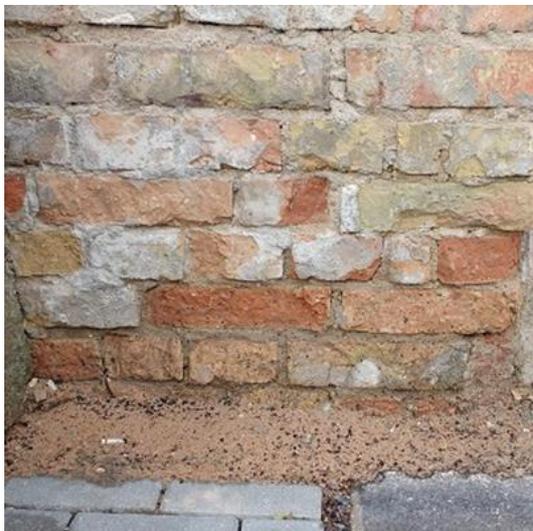
From the surface, the bricks crumbles away

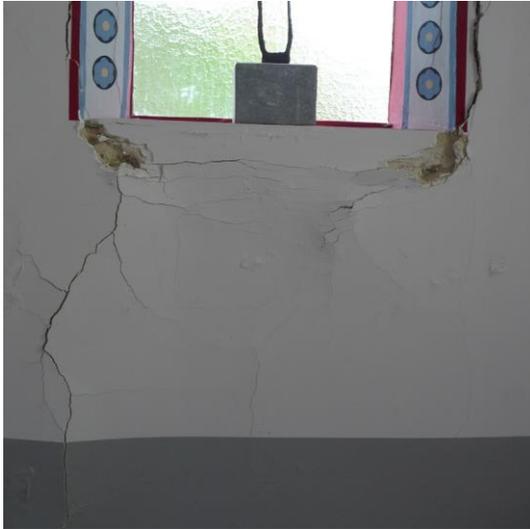
Degradation of plaster due to infiltrations through the façade

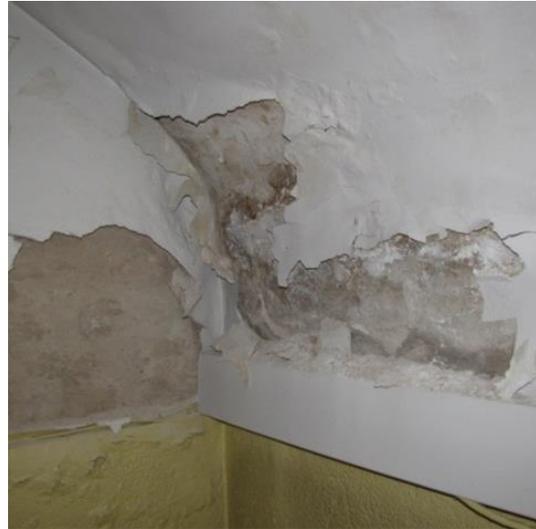
Coating and plaster are spalling off

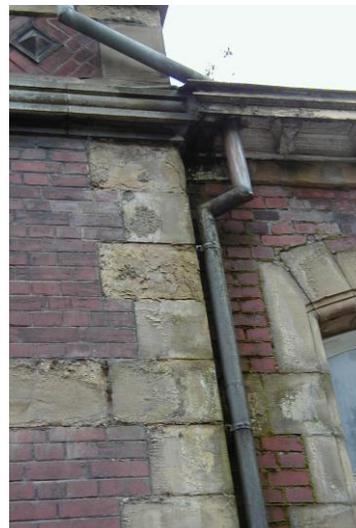
Algae and moss growth due to a defect external downpipe

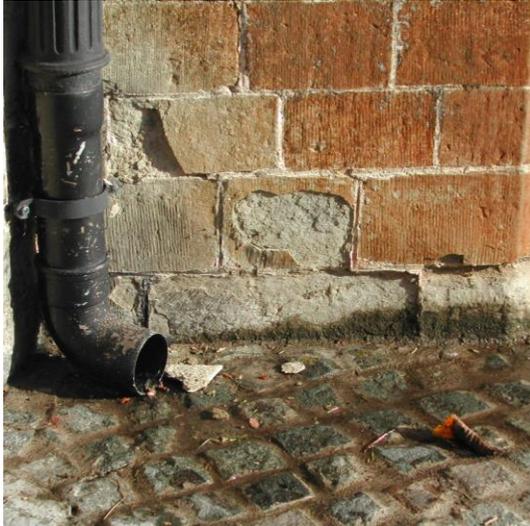
Degradation of natural stone at a wall base, due to wetting and frost.

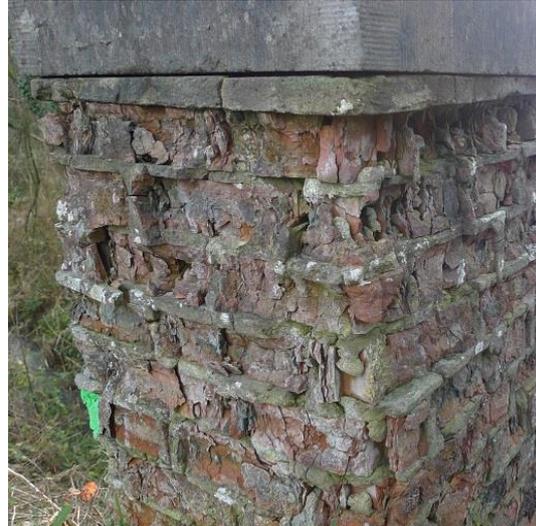
Degradation of bricks, due to abnormal wetting (the capstone is not designed well) and frost.

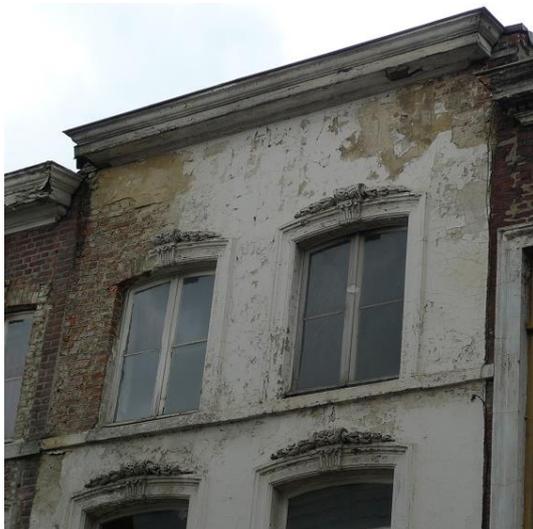
Damage, due to frost, of external render, following the abnormal wetting of the plaster because of a blocked gutter.

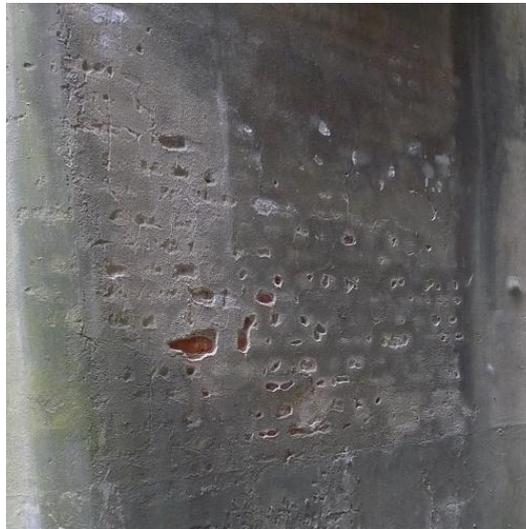
Damage to an exterior render, mainly due to salt crystallisation. The differences in porosity and pore size distribution between render, mortar and bricks give this specific damage pattern.

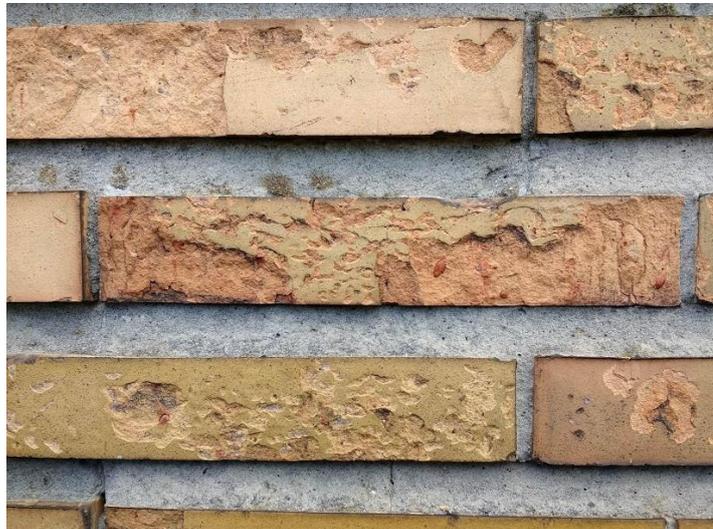
Loss of salt glaze because of frost of the damp material behind the dense finishing layer

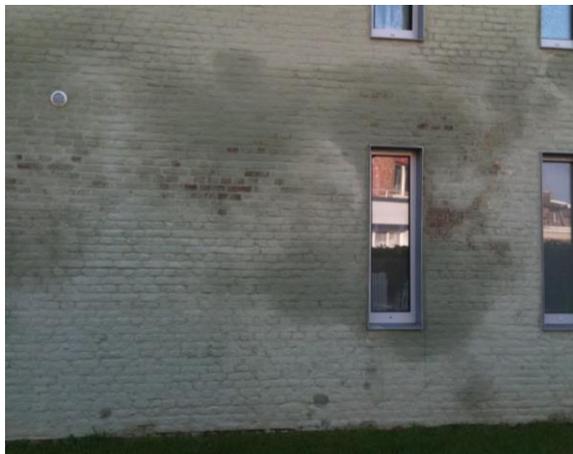
Hygroscopic moisture  
due to hygroscopic salts

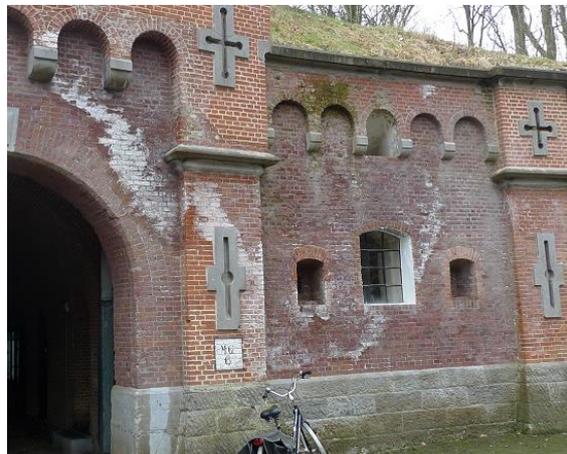
Salt efflorescence  
due to the drying out of a wall

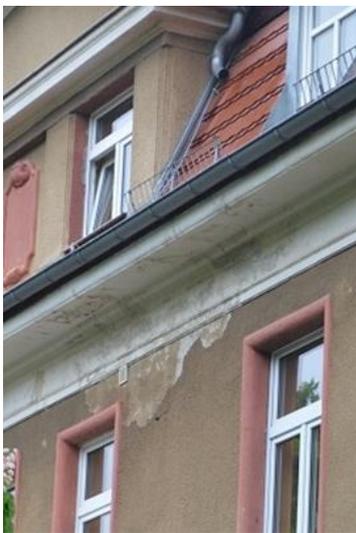
Discoloration on a facade under a rain gutter

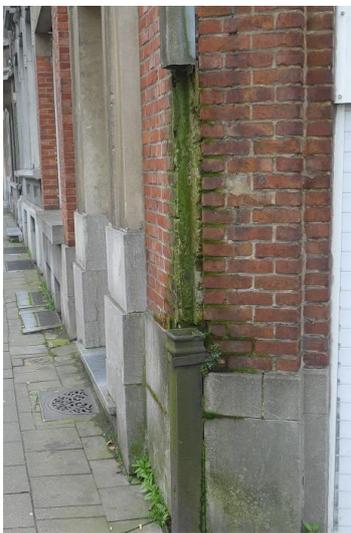
Algae and washed-out mortar due to missing rainwater pipe

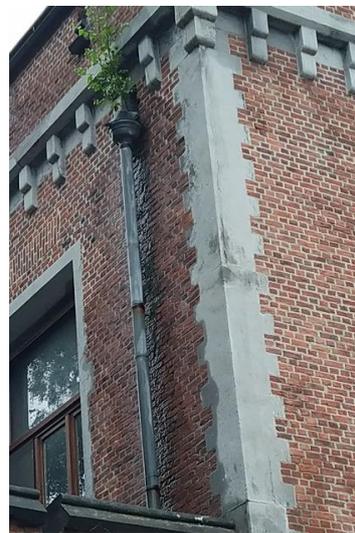
Water running over the façade due to a blockage

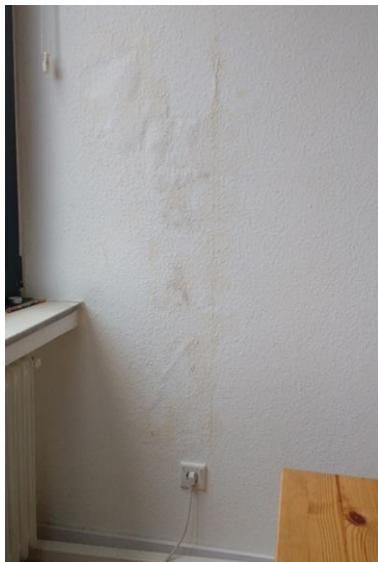
Damp spot in room, partly detached wallpaper

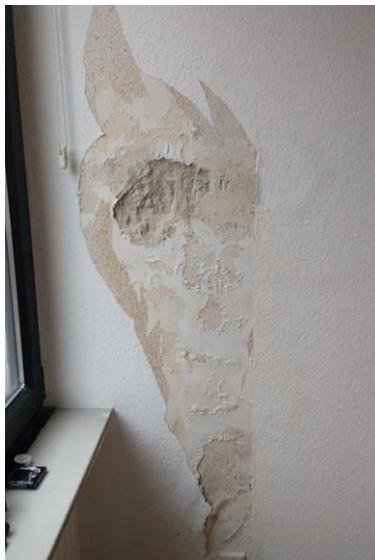
After removing wall paper visible mould stains

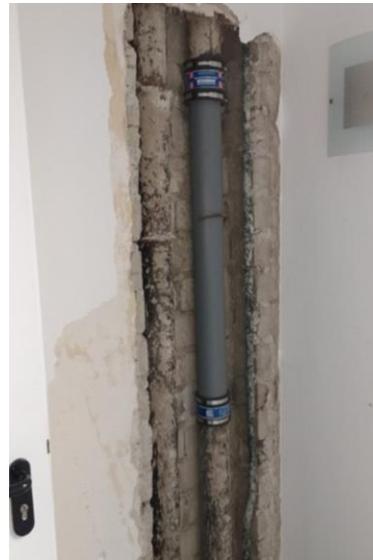
Replaced internal pipe

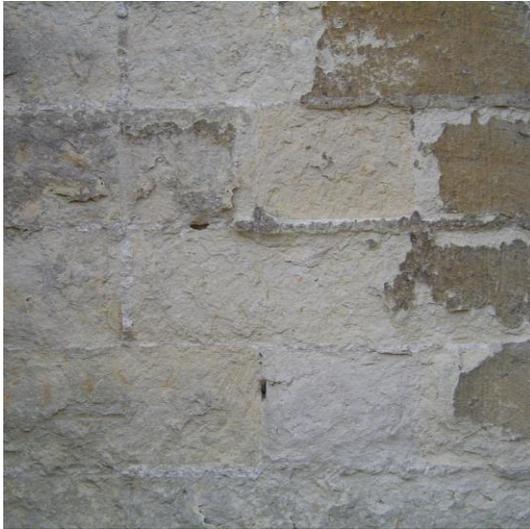
Degraded limestone due to acid rain

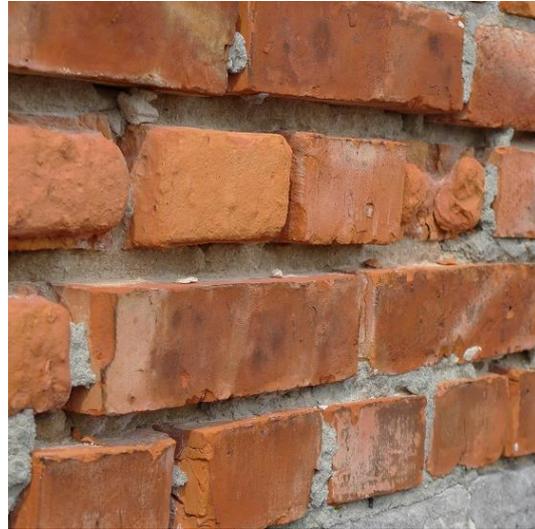
Damaged mortar joints

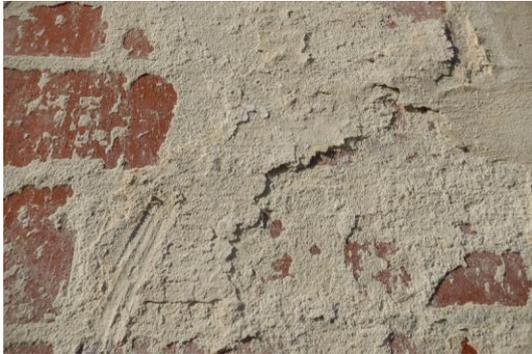
Degradation of a mineral paint

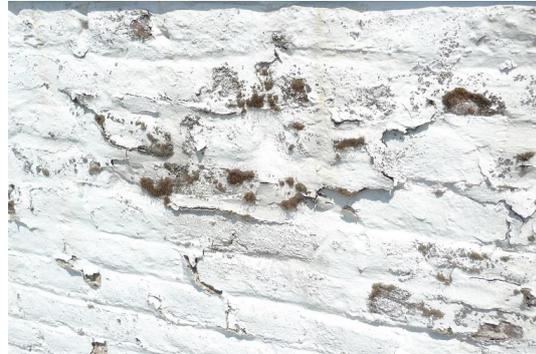
Degradation of a vapour-tight paint

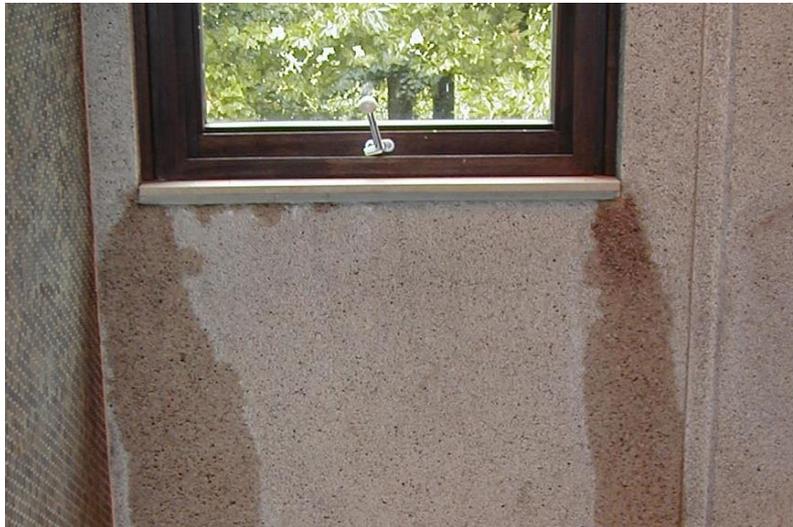
Infiltrations through leaking joints between window and wall

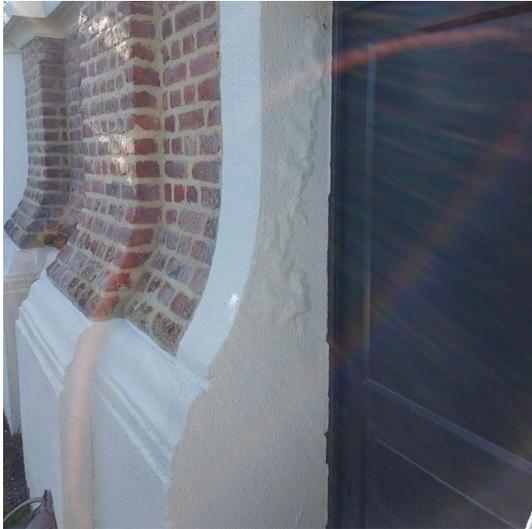
Non-vertical lower part of a façade, exposed to falling rainwater

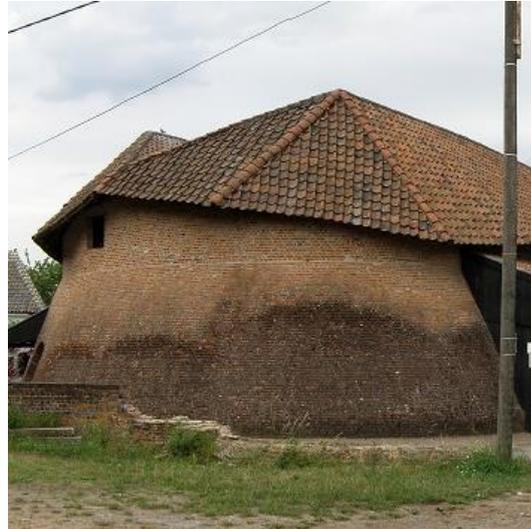
Discolouration of a non-vertical façade due to bacterial growth, caused by rainwater running off a roof without gutter. The bacteria are not the main problem, but a symptom of high rainwater exposure

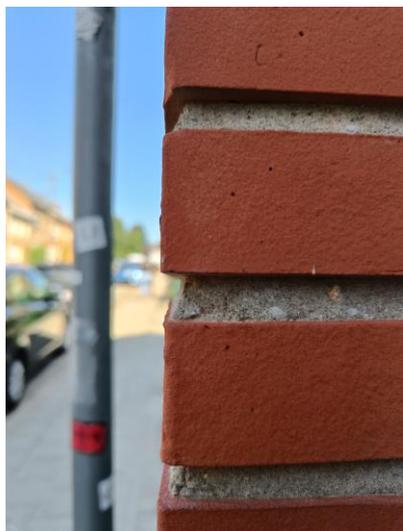
So-called 'shadow-joints' or 'Dudok-joints' offer less protection for infiltration of rainwater, as it has more time to penetrate the brick.

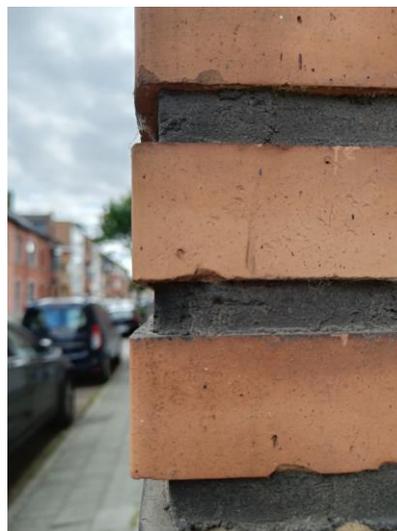
In case of recessed joints, the upper part of the bricks are less protected against rainwater.

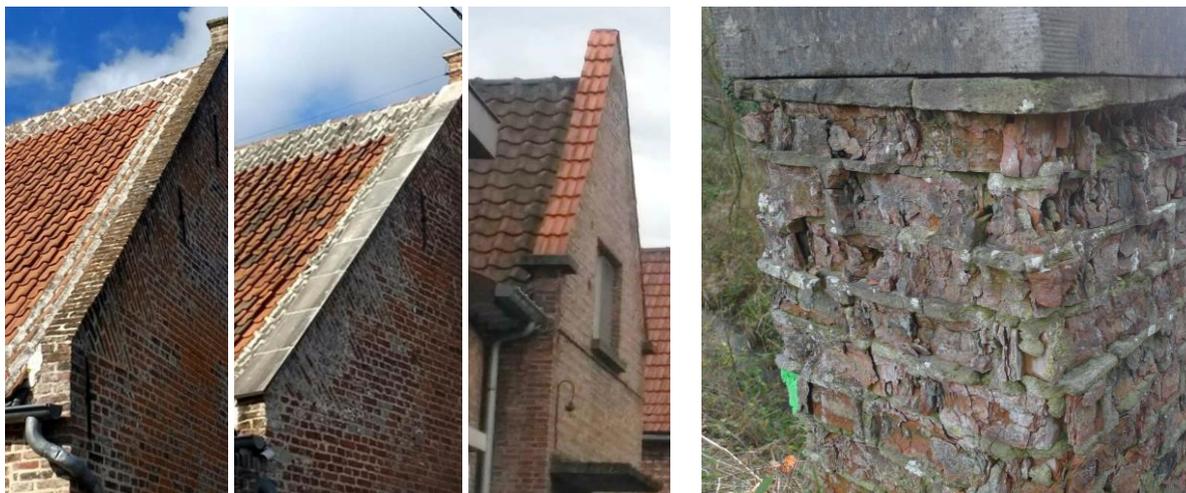
Left: absence of covering gives rise to a serious risk of exceedingly high moisture content in the wall.  
Middle and right: viable solutions for wall covering.

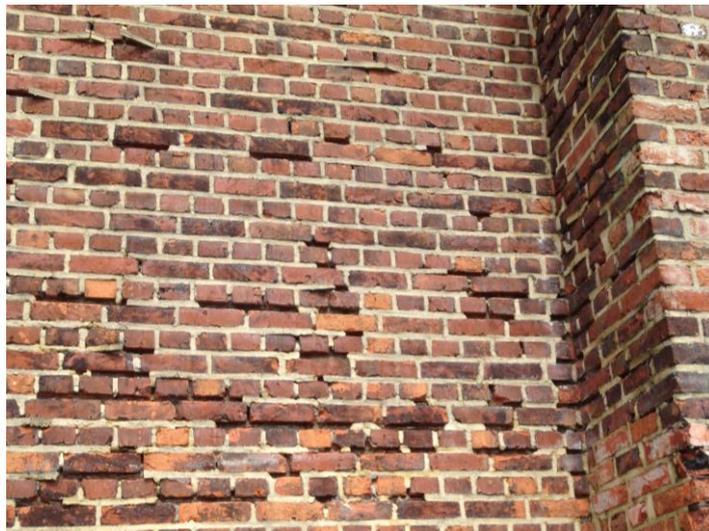
An old masonry, repointed with a mortar with white Portland cement as a binder. The new pointing mortar has been pushed out by frost damage in the older bedding mortar.

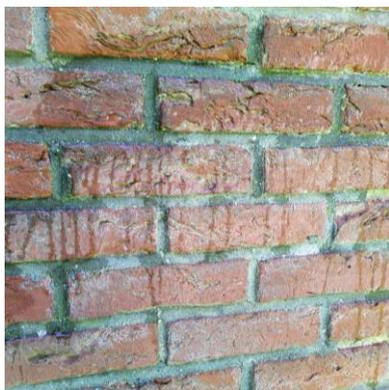
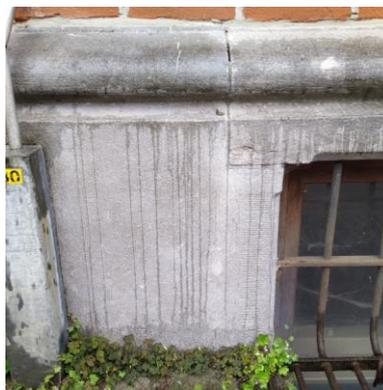
Visual indication of the presence of a water repellent agent:  
the surface cannot be wetted, water that runs off the façade forms fine runoffs or droplets.

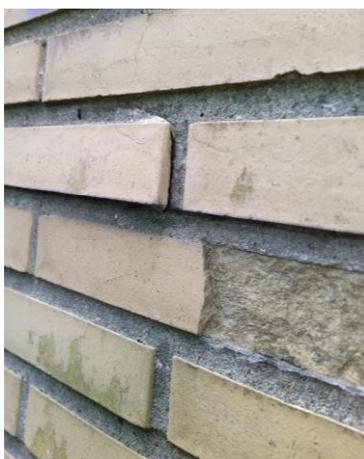
Glazed bricks (~1960s) degrading due to frost and limited drying potential of the masonry

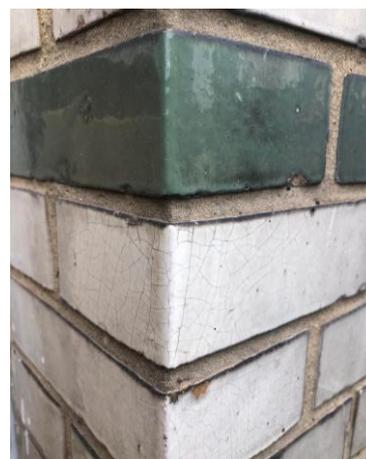
Glazed bricks (early 20th century); masonry can still dry out through the joints in between the bricks

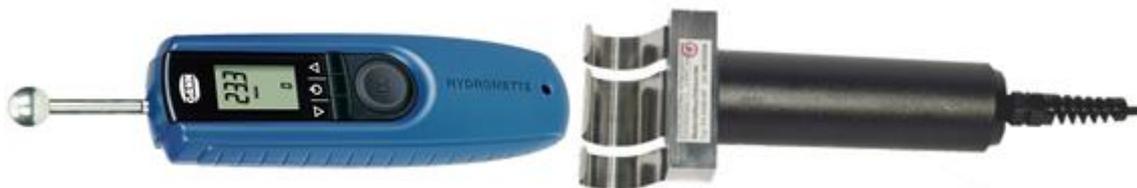
Fig. 19 Measuring instruments for capacitive humidity measurement (left: [www.gann.de](http://www.gann.de), right: [www.ahlborn.com](http://www.ahlborn.com))

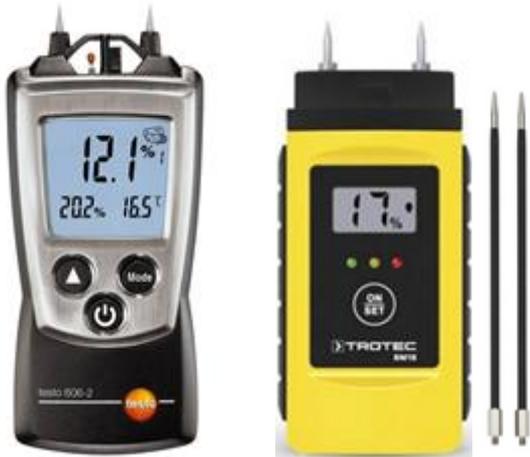
Fig. 20 Resistance moisture meters (left: testo.com, right: www. trotec.de)

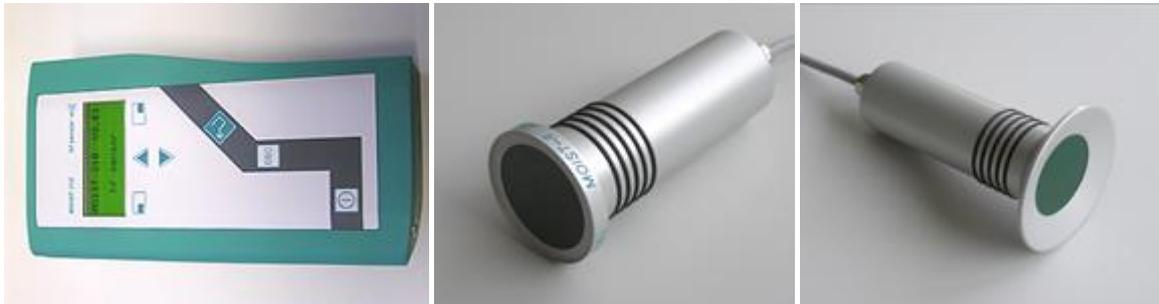
Fig. 21 Microwave moisture meter with different measuring heads (hf-sensor.de)

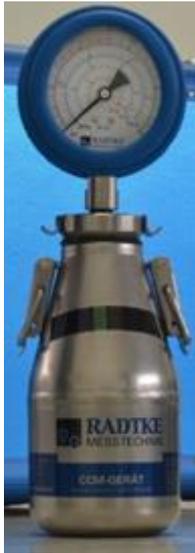
Fig. 22 CM measuring device for humidity measurement (radtke-messtechnik.com)

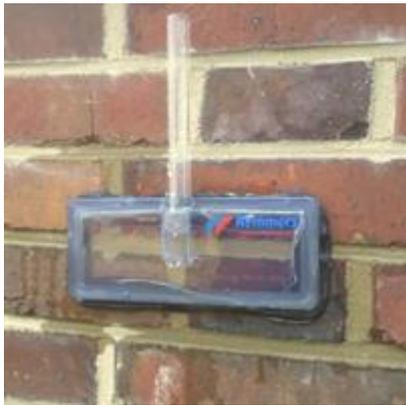
Fig. 25 Testing plate according to Franke, detection of water content in brick and joint

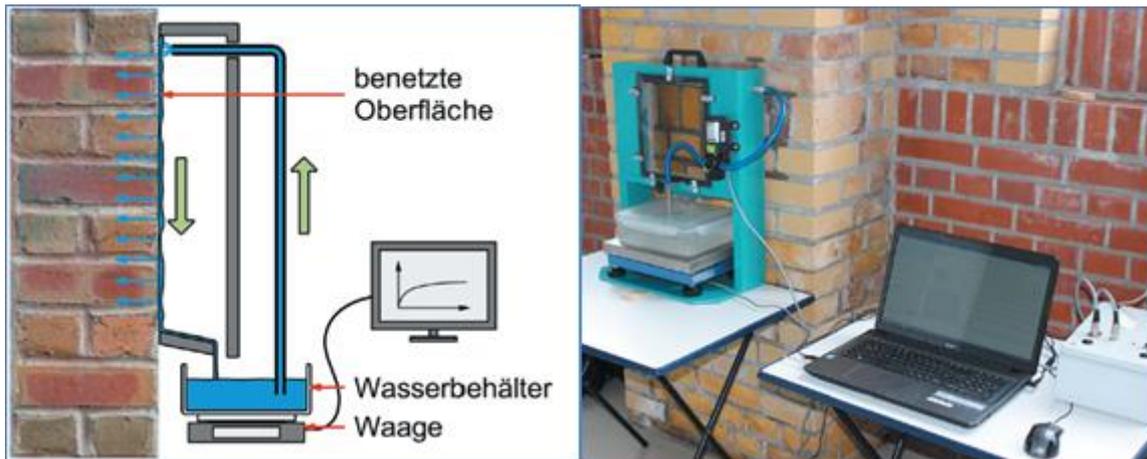
Fig. 26 Water absorption measuring device, measuring principle and practical application [hf-sensor.de]
